Urban Rehabilitation of the Coimbra's "Baixinha" Historical Centre – Portugal

Keywords: rehabilitation, energetic performance, historical centre, sustainability, comfort

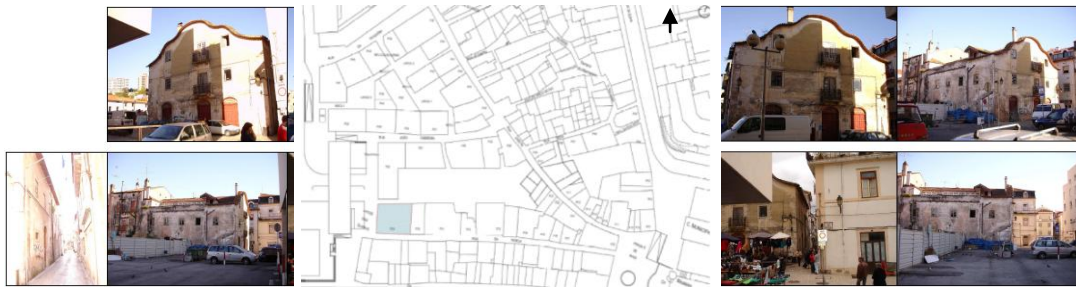
Figure 1: Photos / Study 1 localization

The building stands in Rua na Moeda n° 84-92 / Largo das Olarias, Santa Cruz and was probably constructed at the end of the 19th. century. There is a commercial establishment on the ground floor and residences (7 T0 – studio flats) on the 1st. and 2nd. floors.

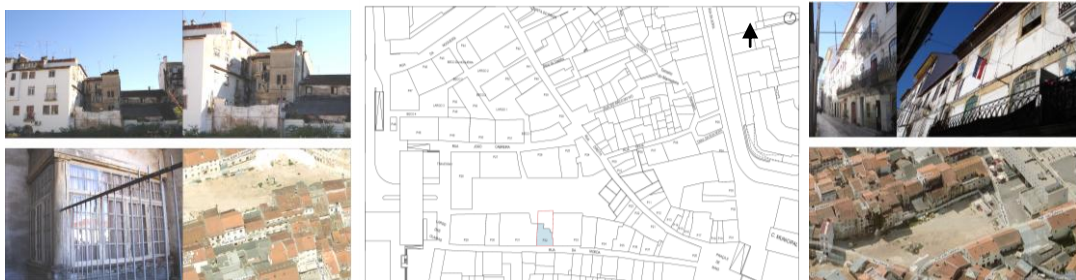
Figure 3: Photos / Study 2 localization

The building stands in Rua da Moeda nº 60-64, Santa Cruz and was probably built at the end of the 19th century. The ground floor serves as a commercial establishment, whilst the 1st, 2nd, and 3rd floors are residential (3 T3s – three-bedroom flats). In this test we studied the 1st floor.
